NOTICE TO MARINERS

Moyle Interconnector Cable Repair Campaign 2: Extension of deburial, retrieval of sealed ends, splicing in a length of spare cable, relaying on seabed and reburial by trenching

Notification of repair work to commence 25th August 2017

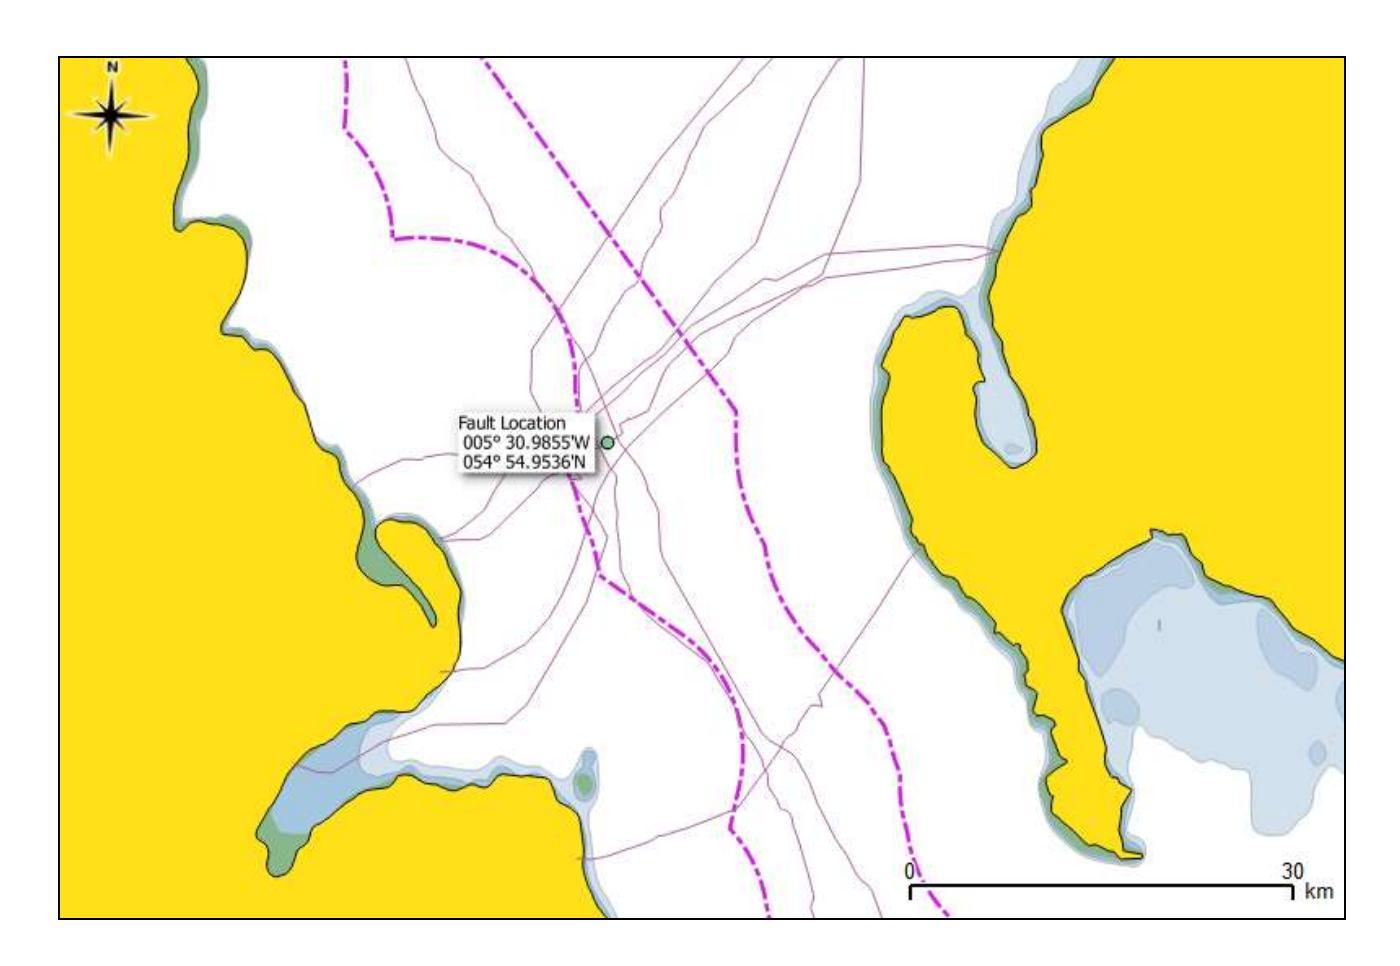
The fault is on the south IRC cable at a point on the seabed centred around the coordinates given in the table below:

Item	Easting & Northing (ED50 UTM30N)		Latitude & Longitude (WGS84)	
	Easting	Northing	Longitudue	Latitude
Fault location	338807	608859	005° 30.9855′W	054° 54.9536′N

This is marked on the map below.
